## Milling Evaluation of Amber Mill®

M. Cowen, J.M Powers

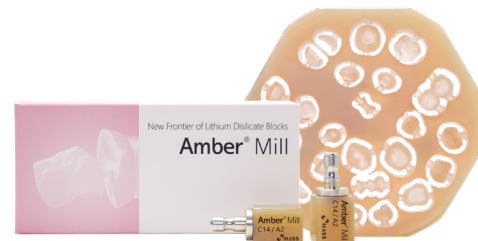
The polishing rate is similar to other glass ceramics, and extended polishing time can achieve an almost glass like appearance with a surface roughness of less than 10 nm. The total peak to trough height after milling was 10.4-11.4 mm. Adequate polishing with an Ra below 200 nm (or 0.2 µm) to minimize bacterial adhesion was achieved within 40 seconds of polishing.

Polishing, means (standard deviations)				
Parameter	Milled	20s	40s	120s
Gloss, gu	3.0 (0.3)	52.6 (4.6)	82.9 (2.3)	99.0 (1.5)
Roughness, Ra, nm	1580 (260)	410 (300)	109 (33)	9.0 (6.4)

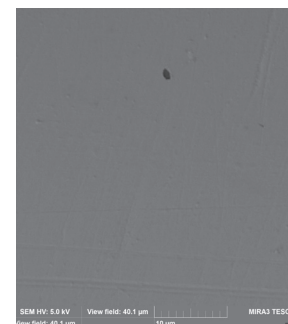
SEM image of a highly-polished surface showing a mirror-like image
